Investigation of finned tubes failure in the furnace of dehydration unit at 10th Refinery of South Pars Gas Complex

This paper focuses on the investigation of finned tube failures observed in the convection section of the dehydration furnace (Unit 104). The tubes were manufactured from ASTM A106 Grade B carbon steel and the fins from AISI 304 stainless steel. To identify the root causes of failure, several experimental techniques were employed, including optical microscopy, Field emission scanning electron microscopy (FE-SEM), X-ray diffraction (XRD), X-ray fluorescence (XRF), and corrosion testing in accordance with ASTM A262-15 (2021) Practice A.

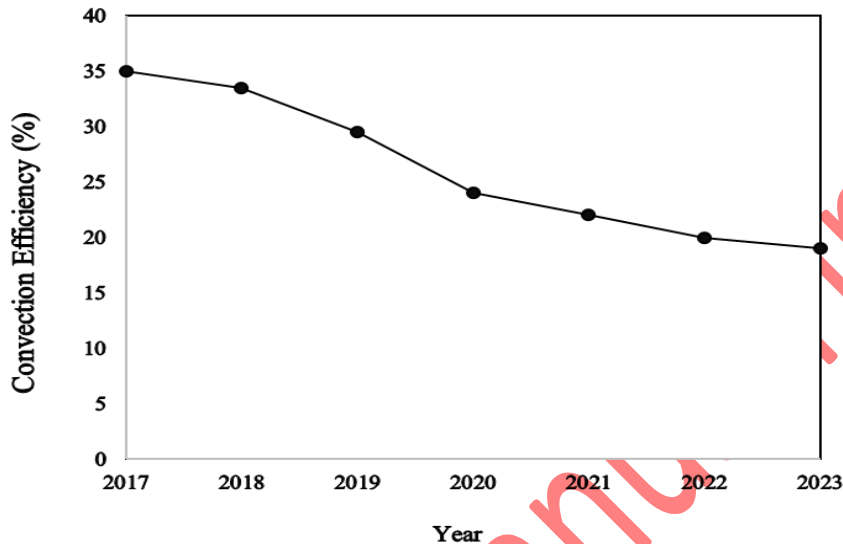
The efficiency of the convection section of the second-row furnace of the 10th refinery was about 34% at the beginning of commissioning in 2017, which has fallen below 20% over time, as shown in Fig. 3.

Figure 3. Declining trend in efficiency of the convection section of the boiler

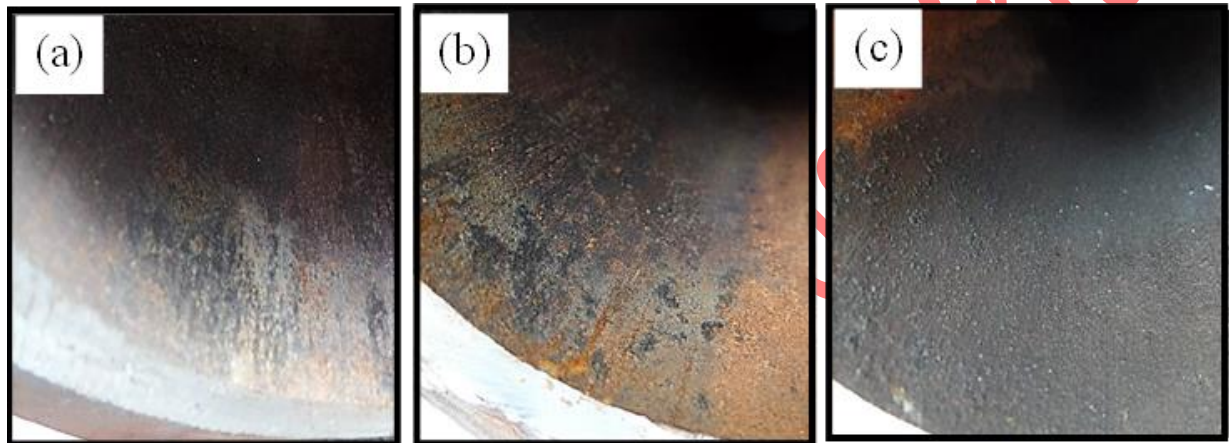
Visual Evaluation of the tube was performed by determining four hypothetical positions 3, 6, 9 and 12 o'clock on the tube. **There are some colorful deposits on inner tube side. At the**

hypothetical position 12-3 and 3-6 o'clock (**Fig. 4. (a & b)**) brown and black products are clearly seen, also at the hypothetical position 6-9 o'clock (**Fig. 4. (c)**) only black products are observed besides shallow holes, however only at the hypothetical position 6 o'clock, radial cracks are observed in the fins along the tube (**Fig. 4.**). Also, the cracks in the tube and the radial cracks in the fin section are connected to each other (**Fig. 5.**). Considering the connection of the cracks in the fin and tube and their alignment, there is a possibility that the origin of the crack initiation is the same in both.

Figure 4. Formation of deposits at (a) 12-3 o'clock, (b) 3-6 o'clock, and (c) 6-12 o'clock hypothetical positions

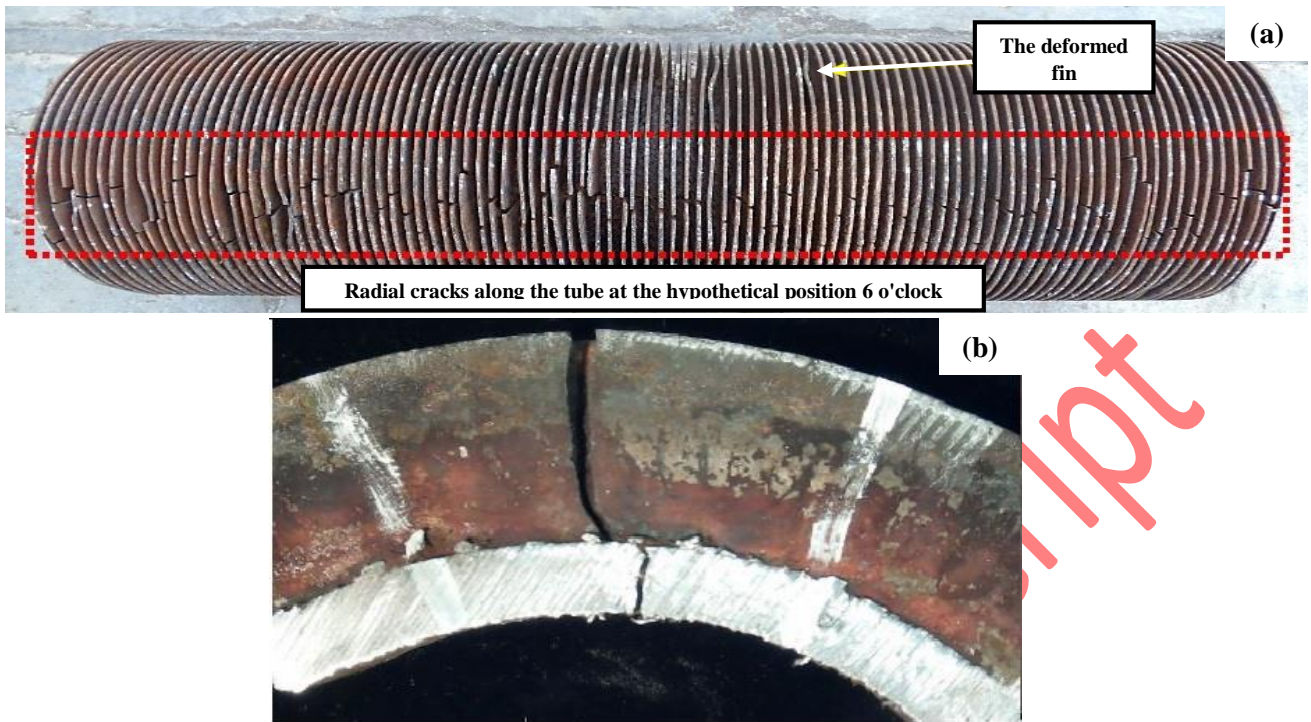
Figure 5.(a) Radial cracks on the fin and (b) crack propagation in both the tube and the fin

- Based on visual inspections, all cracks occurred at the hypothetical 6 o'clock position, and the cracks in the fin and tube were not only aligned but also connected to each other.
- Based on the results of emission spectrometry, hardness measurements, and tensile testing for both the tube and fin materials, and considering their conformity with the furnace

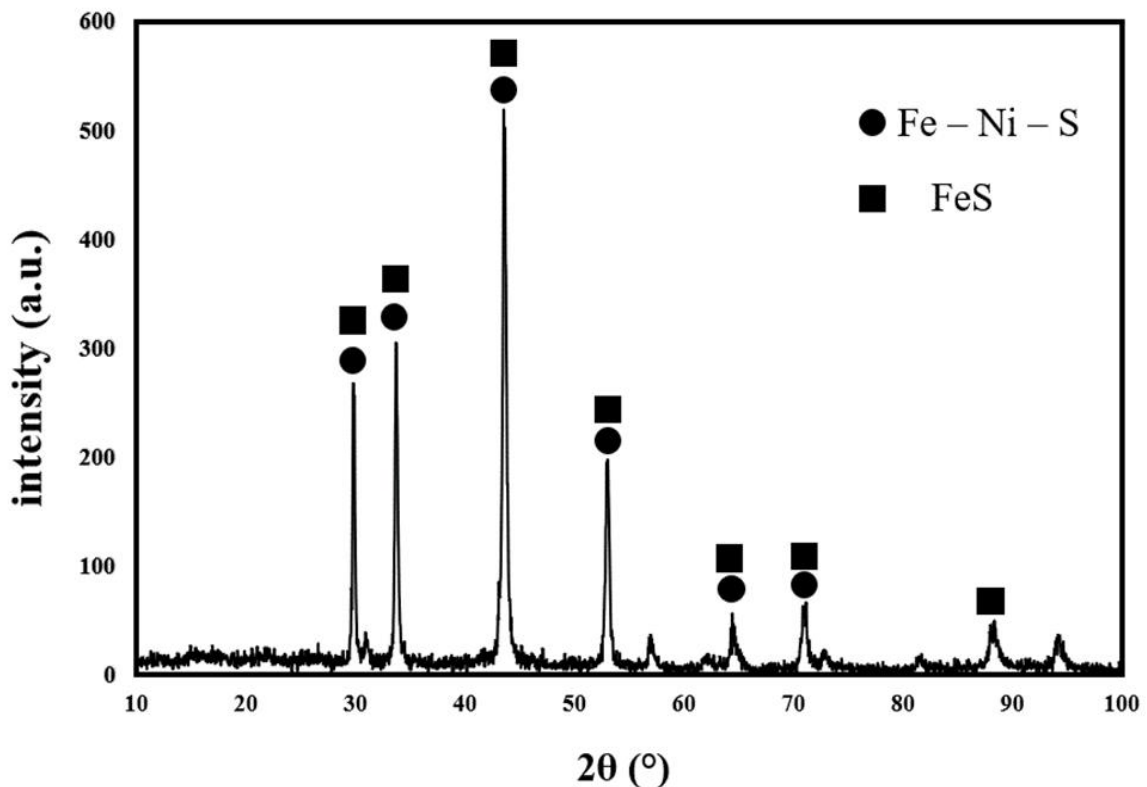
The tube Internal surface deposit's structure was investigated by XRD analysis. Fig. 6. illustrates the XRD pattern of the tube Internal surface deposits. It can be seen in Fig. 6. two reference codes were matched with the detected peaks in the XRD pattern. Reference code JCPDS 969013705 for Fe-Ni-S compound (Fe_{43.96}Ni_{4.00}S_{49.00}) named Pyrrhotite with

Monoclinic structure has seven detected peaks at diffraction angle 29.85° , 33.75° , 43.61° , 53.01° , 57.03° , 64.52° , 71.00° can be assigned to (025), (043), (046), (065), (228), ($\bar{1}45$), (086) crystallographic planes of the Fe-Ni-S compound respectively. Also, the peaks detected by JCPDS 961504401 reference code is about FeS with Hexagonal structure at the diffraction angle of 29.82° , 33.69° , 43.49° , 52.94° , 56.78° , 64.44° , 70.85° and 88.30° that could be related to (100), (101), (102), (110), (103), (004), (202) and (114) crystallographic planes. Based on the detected phases, it can be noted that the sulfide products have made on inner surface tube.

Figure 6. XRD patterns of tube internal surface deposits

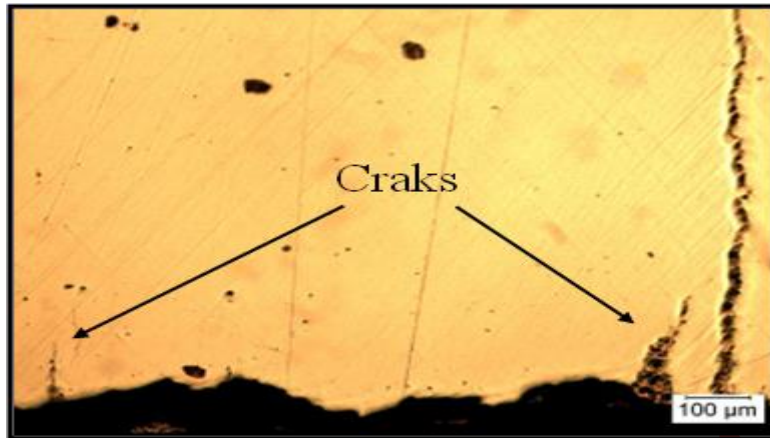
Microscopic examination of the tube cross-section reveals the presence of multiple parallel cracks exhibiting both sharp and occasionally rounded (Fig. 7.) First, by etching the boundary between the fin and the tube with 2% Nitrel solution, ferrite grains along with pearlite rows were visible in the tube structure, and the cracks have grown intra-granularly in this part (Fig. 8.). Also, microscopic defects were visible at the boundary of the fin-tube connection (Fig. 9.). The heat-affected zone (HAZ) on the tube side predominantly comprises a ferritic matrix with a dispersed distribution of carbides and localized pearlitic

Figure 7. Multiple microcracks with sharp points on the tube

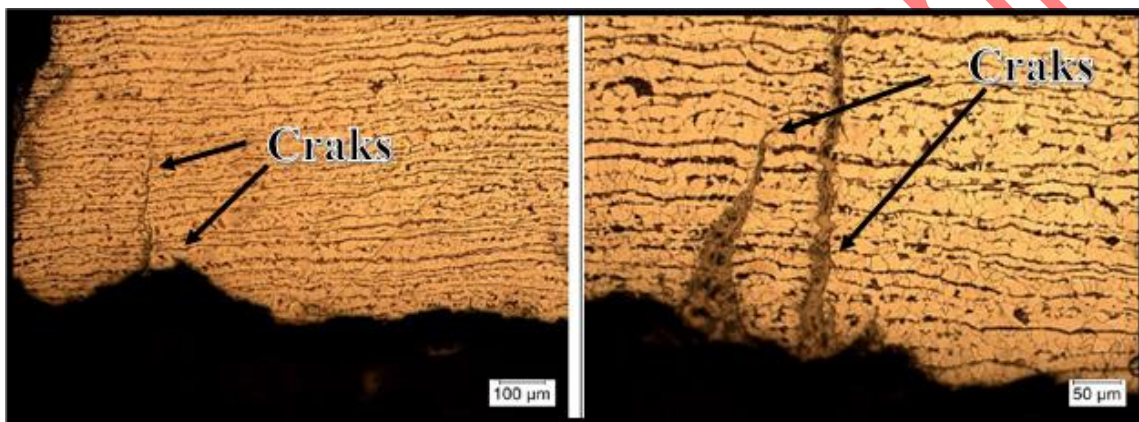
regions. Microstructural analysis indicates that crack propagation occurred trans-granularly. The observed features are attributed to the high thermal input during welding and the absence of subsequent post-weld heat treatment (**Table 11.**), the microscopic structure in this area has undergone some changes and has changed from a fine-grained state to a coarse-grained state (**Fig. 9.**), which has caused residual stresses to remain in this part. The interaction between residual stresses and operational thermal stresses arising from the continuous exposure of these tubes to fluctuating thermal cycles can facilitate the detachment of the fin from the tube. Also, the coarse-grained area is prone to the initiation or propagation of other cracks into the tube. Therefore, improper welding and residual stresses are among the reasons for the presence of microscopic defects at the fin-tube junction. It should be noted that the defective fin-tube junction in some parts is likely to deposit corrosion products. (**Fig. 11.**) Regarding to post-heat treatment, attention should be paid to the possibility of sigma phase formation in 304 stainless steels [22]. Therefore, performing solution annealing at a temperature above the sigma-phase formation range (590–870 °C) can inhibit sigma-phase precipitation in the fin and promote microstructural refinement in the tube section from

Figure 8. Crack propagation intragranularly in the tube internal side at scale (a) 100 μm and (b) 50 μm

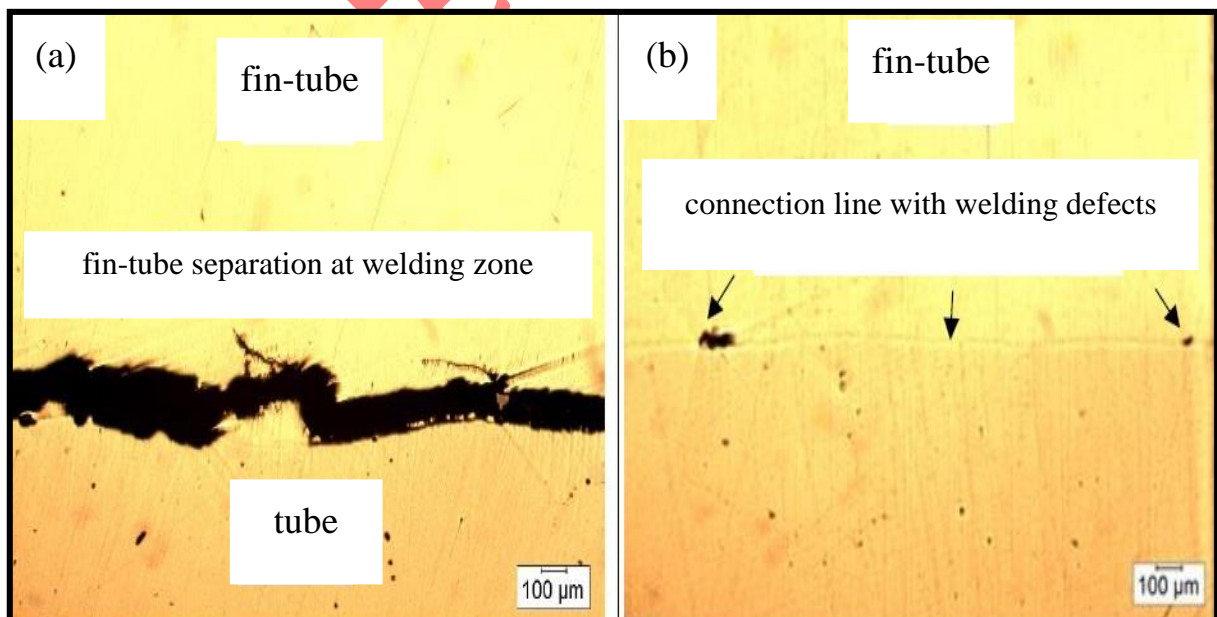
Figure 9. (a) Fin-tube separation at welding zone (b) welding defects along fin-tube connection line

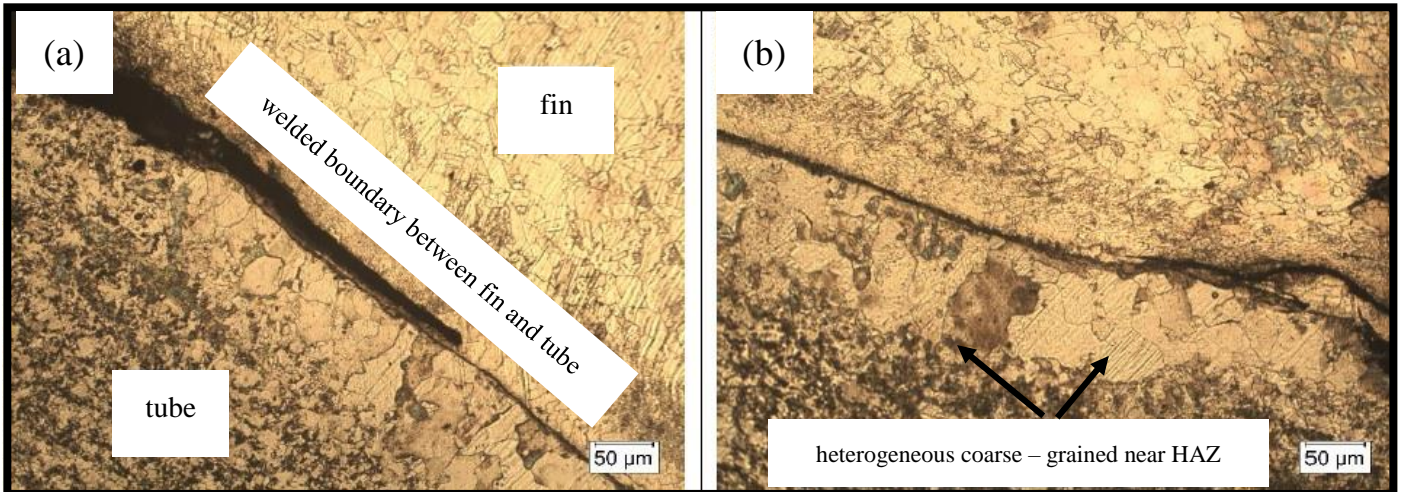
Figure 10.(a) and (b) coarse-grained structure near the weld line

- By examining the microscopic structure of the tube, in addition to the appearance of intra-grain crack growth, a coarse-grained HAZ structure is visible at the fin connection boundary.

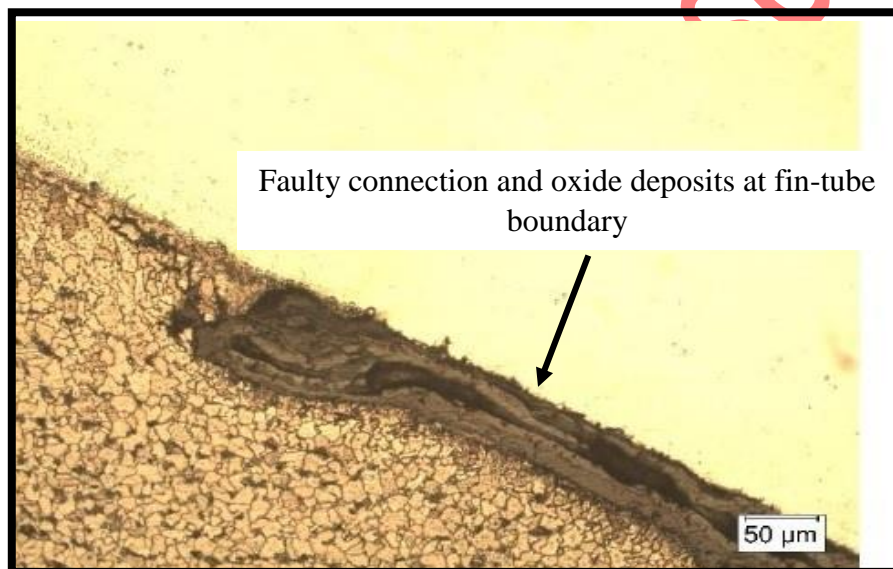
Figure 11.Faulty connection at fin-tube boundary

Due to the difference in the heat transfer coefficient of the materials used in the fin and the tube (tube material: ASTM A106 grade B, fin material: AISI 304), the presence of numerous welding defects, and the accumulation of impurities among these defects, heat transfer from the fin surface to the tube has not taken place properly, and the fin surface has become the location of heat concentration (the fin surface temperature, according to field surveys, was in the range of 700 to 800 °C) [16]. This heat concentration in the fin brings some difficulties such as; first, formation of chromium carbide (at temperatures above 500 °C, the probability of chromium carbide formation increases greatly), which is a brittle compound, at the grain boundaries. Then, afterwards Due to the mismatch in the coefficients of thermal

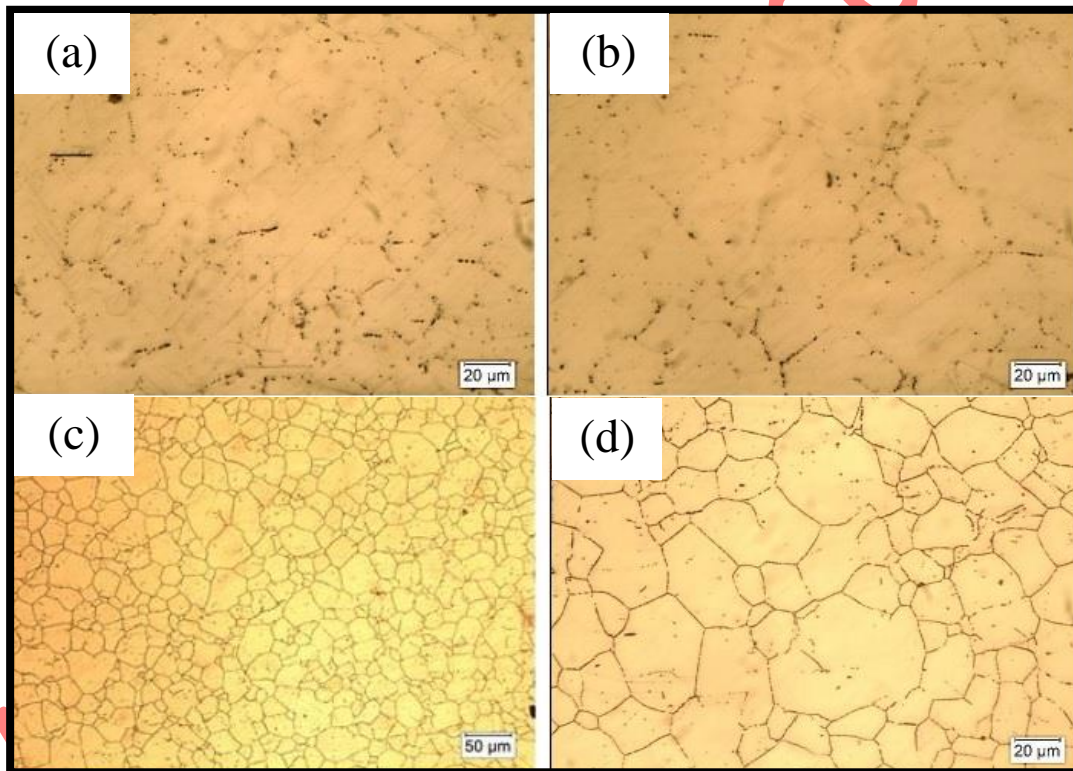
Figure 12.(a &b) Longitudinal section of the fin and (c &d) Fin cross-section after etching

- By evaluating the microscopic structure of the fin after etching, in addition to the grain boundary crack growth, the accumulation of chromium carbide at the grain boundary is also evident.

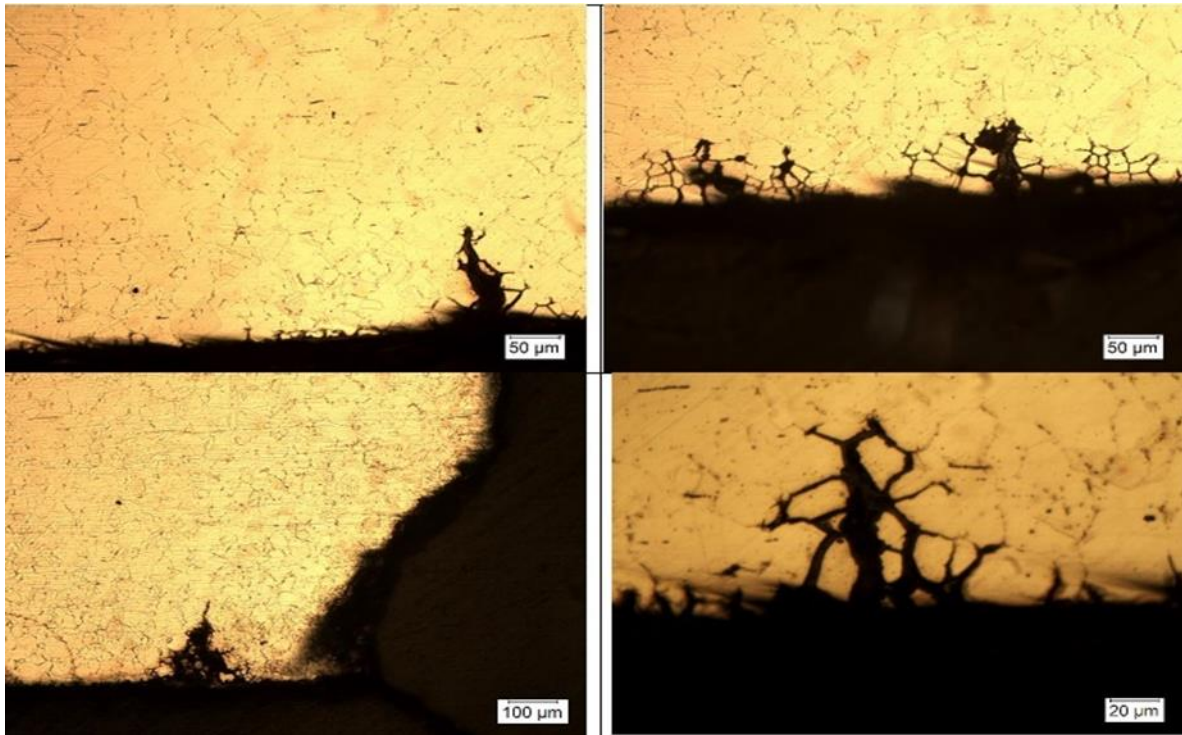
expansion and the localized heat distribution between the fin and tube, intergranular parallel cracks propagated toward the tube surface. This phenomenon is further attributed to the presence of chromium carbides within the fin region. These crack growths are because of the coarse-grained structure in the weld area, which has weaker mechanical properties than other parts of the tube. The aforementioned cracks continued until they reached the inner surface of the tube, and then leakage from the tubes began and a fire occurred. By etching the longitudinal section of the fin with glycyrrhizin solution and the transverse section of the fin with oxalic acid, austenite grains with distribution of chromium carbide particles at the grain boundaries can be seen (**Fig. 12&13**). Also, cracks in the fin section were between the grains, which indicates the sensitization of the steel (**Fig. 14.**).

Figure 13. Crack propagation in the fin section from the grain boundary at different scales

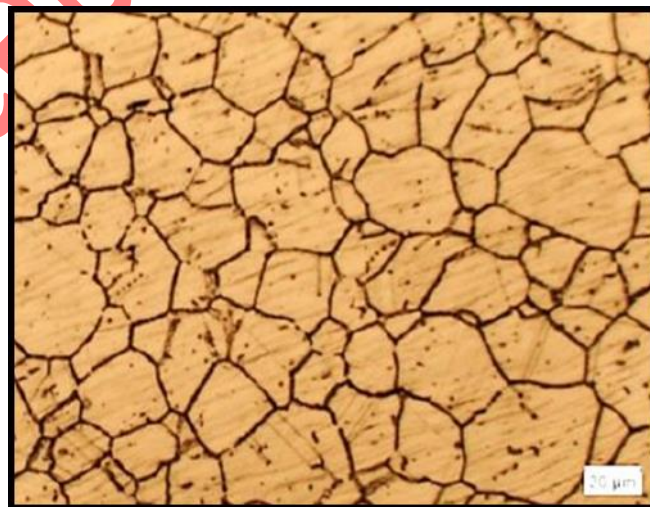
Fig. 14 shows that according to the ASTM A262-15 Practice A, the fin surface is dual in structure and its grain boundaries have become sensitive and are no longer resistant to grain boundary corrosion.

Figure 14. Dual fin microstructure

- Grain boundary corrosion sensitivity testing revealed that the grain boundaries exhibited insufficient resistance to intergranular corrosion.
- The results of the FESEM test show, besides the grain boundary crack growth in the fin section, there are some oxide and sulfide compounds in the inner part of the tube and on the fin surface, which confirms the occurrence of high-temperature oxidation and sulfidation processes.

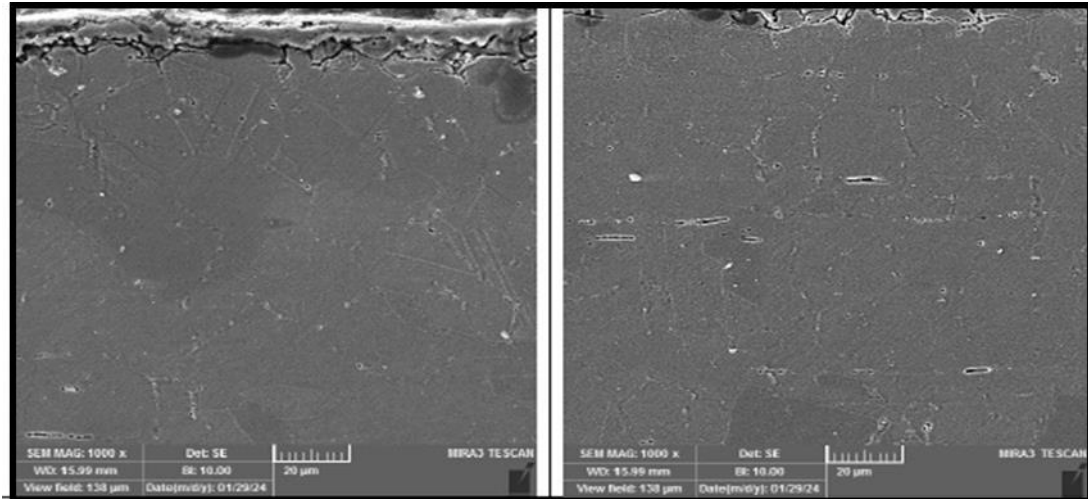
Fig. 15. is a longitudinal cross-section of the fin after etching, in which the growth of cracks between the grains can be seen.

Figure 15. Cracks propagation between the grains of the fin on two different sides

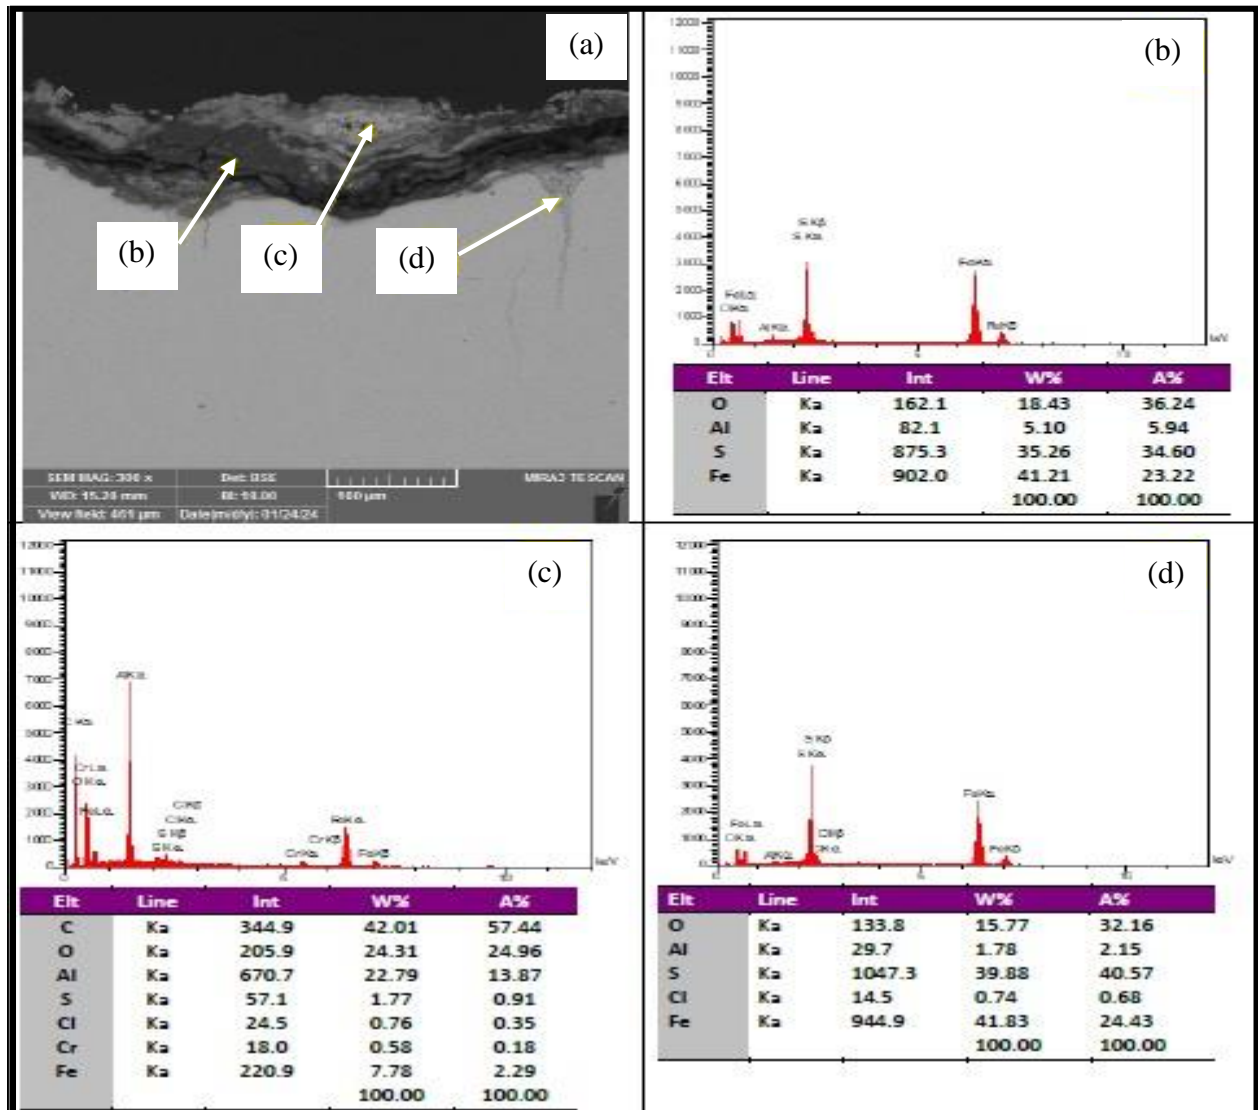
Figure 16. FE-SEM image taken from inner surface of the tube (a) and EDS analyses of 3 random points (b, c and d)

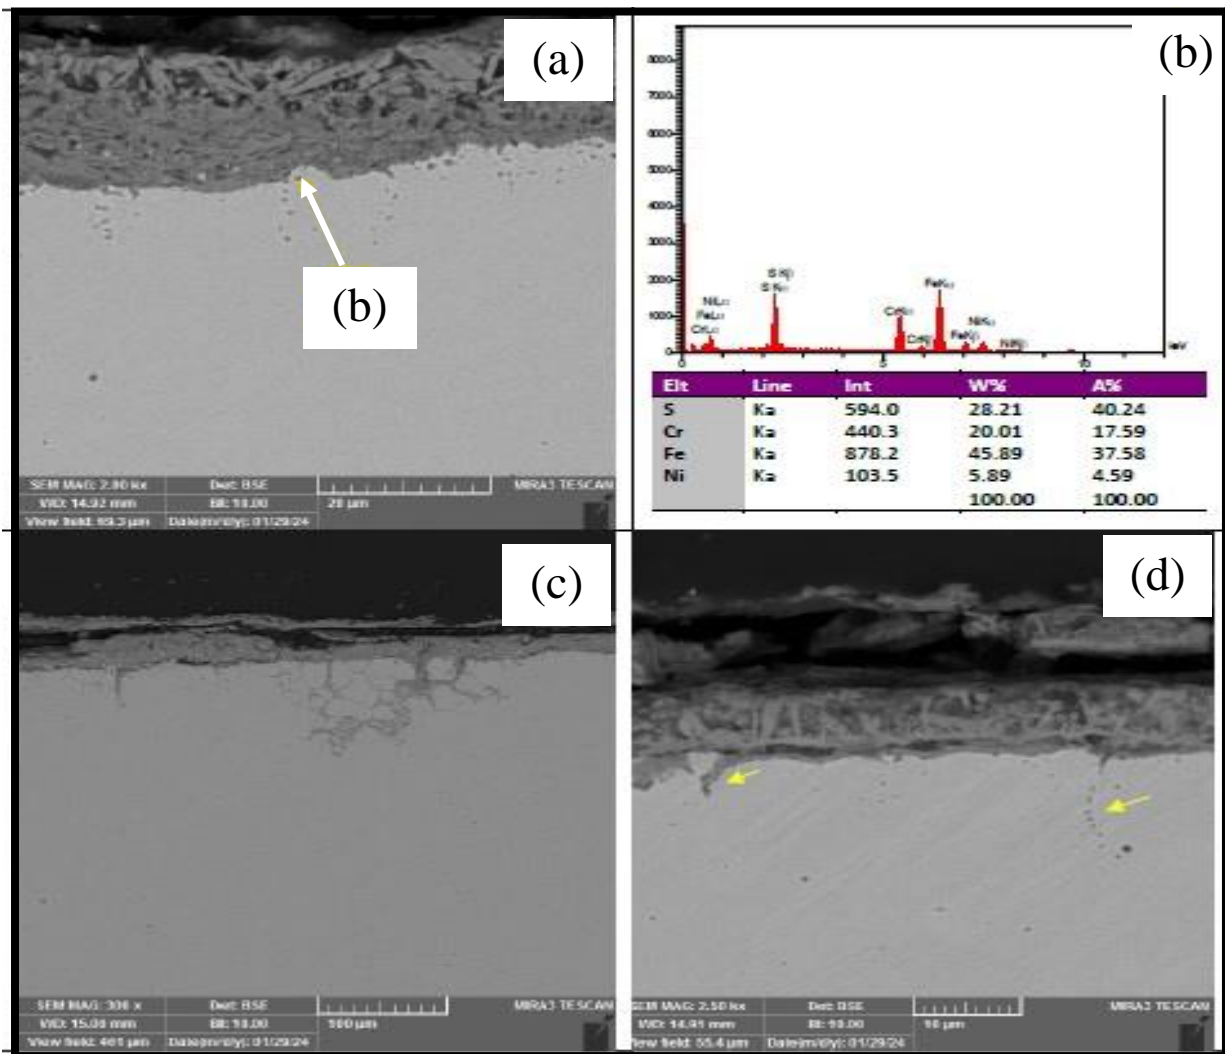
Sulfidation phenomenon, also called sulfide corrosion, is corrosion that occurs due to the penetration of sulfide compounds into the alloy at high temperatures, which can cause localized corrosion in the alloy [23, 24]. According to the studies of the deposits in the cracks of the tube and the fin inner surface by Energy Dispersive X-ray Spectroscopy (EDS test), sulfide and oxide compounds formation was quite evident. Presence of these compounds prove sulfide corrosion and also oxidation during crack propagation along the fin and tube surfaces, as well high percentage of Sulfur (S) confirms sulfidation [25, 26]. (**Fig. 16.**). Based on EDS extracted data Cl element is observed. Because of high humidity and placing near sea formation of chloride compounds could be possible. High concentrations of iron, chromium, sulfur, and the formation of a sulfide phase are displayed in EDS data **Fig. 17.** The phenomenon of sulfidation on the fin surface indicates that the tube has been operating in service conditions in environments containing S and H₂S at high temperatures [27]. **Fig.**

17 demonstrates that the deposit layer has penetrated into the grain boundaries beneath the fin surface and cracks have spread into the grain boundaries [28].

Figure 17. FE-SEM image taken from inner surface of the fin surface and EDS analysis of a random point (a & b) and cross section of the fin surface at two different scales (c & d)
