Development of a Road-Condition Assessment System and Application to Road Maintenance Decision-Making

Miyamoto, A.^{1*} and Ximenes, H.D.C.²

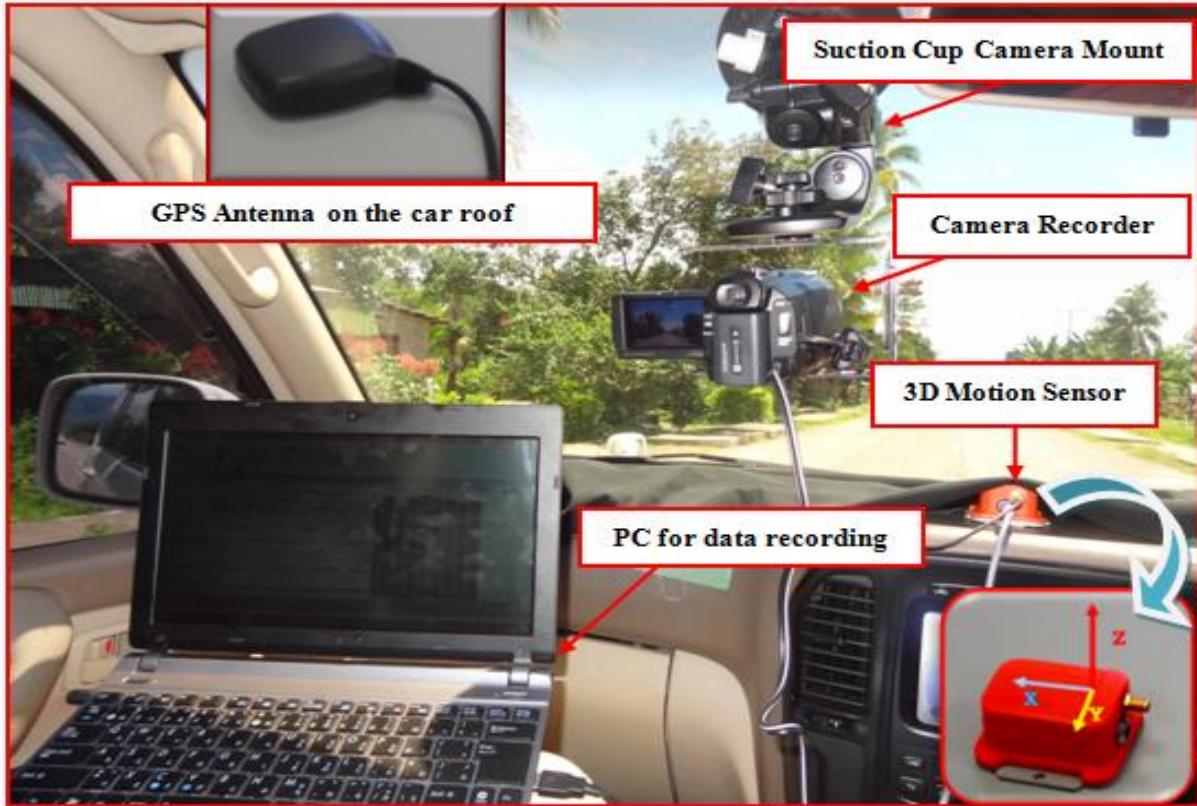
Fig. 1. Arrangement of measuring equipment installed in a car

This section gives a brief overview of how data analysis is performed. Data are obtained using a three-dimensional motion sensor, a GPS system equipped with a gyro and an acceleration sensor, a high-resolution camera, and a microphone. Figure 1 shows the equipment installed in a vehicle. It takes about 20 min to install and start-up the measuring equipment. The system sensor acquires GPS log data. Thus, the acceleration, time (GMT), angular velocity, geomagnetic and orientation sensor information, an orbital plan view and satellite reception conditions can be recorded. The GMT time is very important for synchronizing the video information with the sensor information. In addition, items displayed on this screen can be selected independently, and the scale of the viewing area can be arbitrarily set

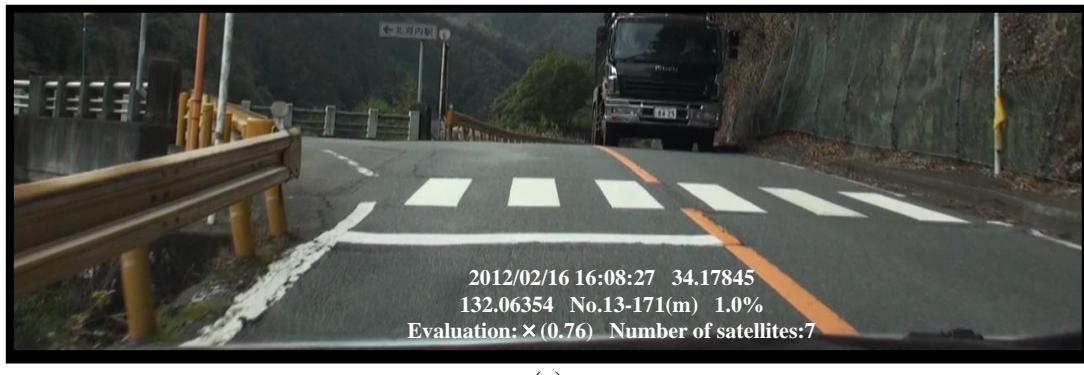
Fig. 6. a) Example of evaluation results using video file with subtitles; and b) Example of evaluation results using web map file

Table 1 shows an example of the output data in an Excel file. Figure 6a shows an example of a video and subtitle file that illustrates the road situation using video, and Figure 6b shows an example of output data indicating the condition of the road as web map data, showing the road condition using three highlighted colors: red for bad, yellow for moderate, and green for good.

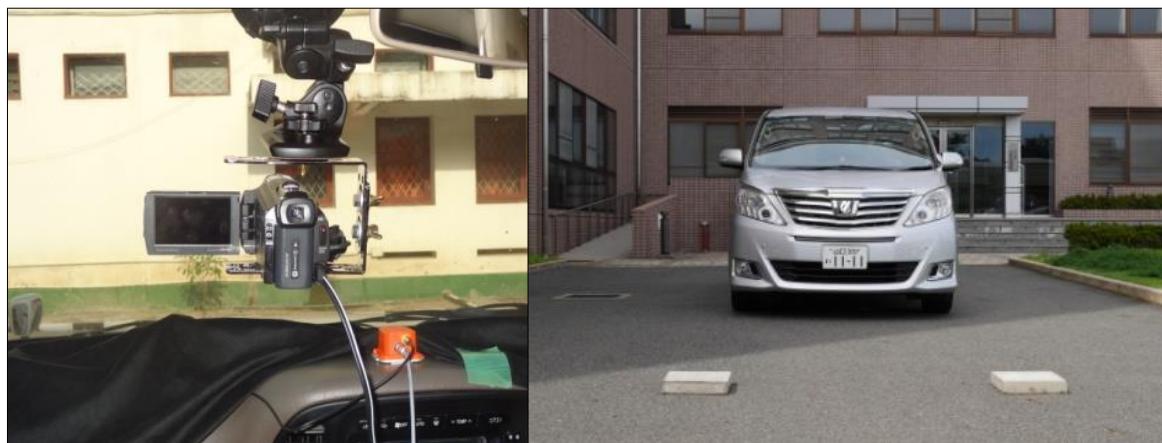
Fig. 10. Set-up in measurement vehicle

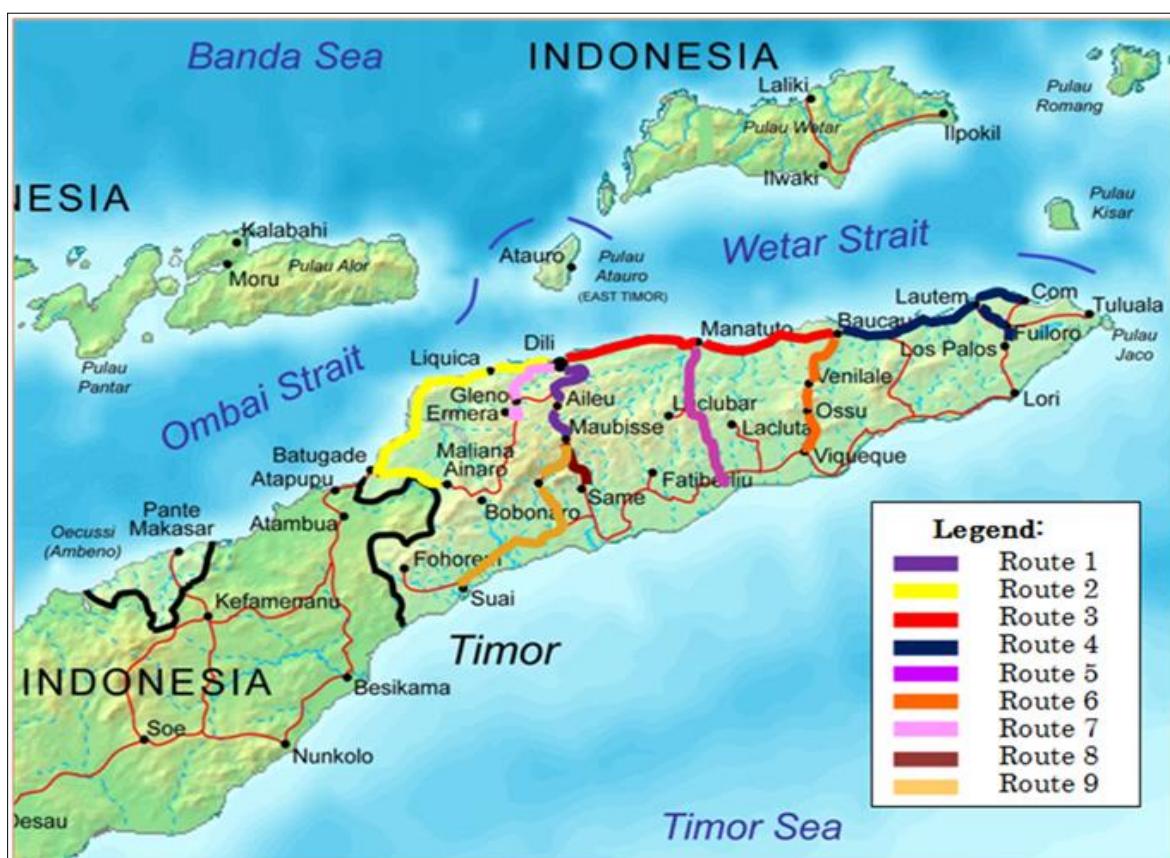
Fig. 13. Timor-Leste road network and routes targeted by the study

Figure 13 shows the target routes for the research. Table 6 lists the road routes and the corresponding distances, which together give a total distance of 740.3 km, and which are regarded as national priority roads connecting the capital city to the district cities of Timor-Leste.

The analysis of the road pavement conditions in Timor-Leste was based on data obtained by the measurements at the location shown in Figure 13. The measurement was divided into four sessions due to the limited budget, as shown in Table 9. The first measurement was conducted from March 25 to 27, 2014 and covered three routes, named route I (No. 1), route II (No. 2) and route III (No. 3). The only route examined in the second measurement was called route IV (No. 4), and was conducted from July 3 to 4, 2014. The third measurement was conducted from March 18 to 20, 2015, and covered two routes, named route V (No. 5) and route VI (No. 6). Lastly, the fifth measurement was conducted from May 13 to 17, 2015, and covered three routes, named route VII (No. 7), route VIII (No. 8) and route IX (No. 9).

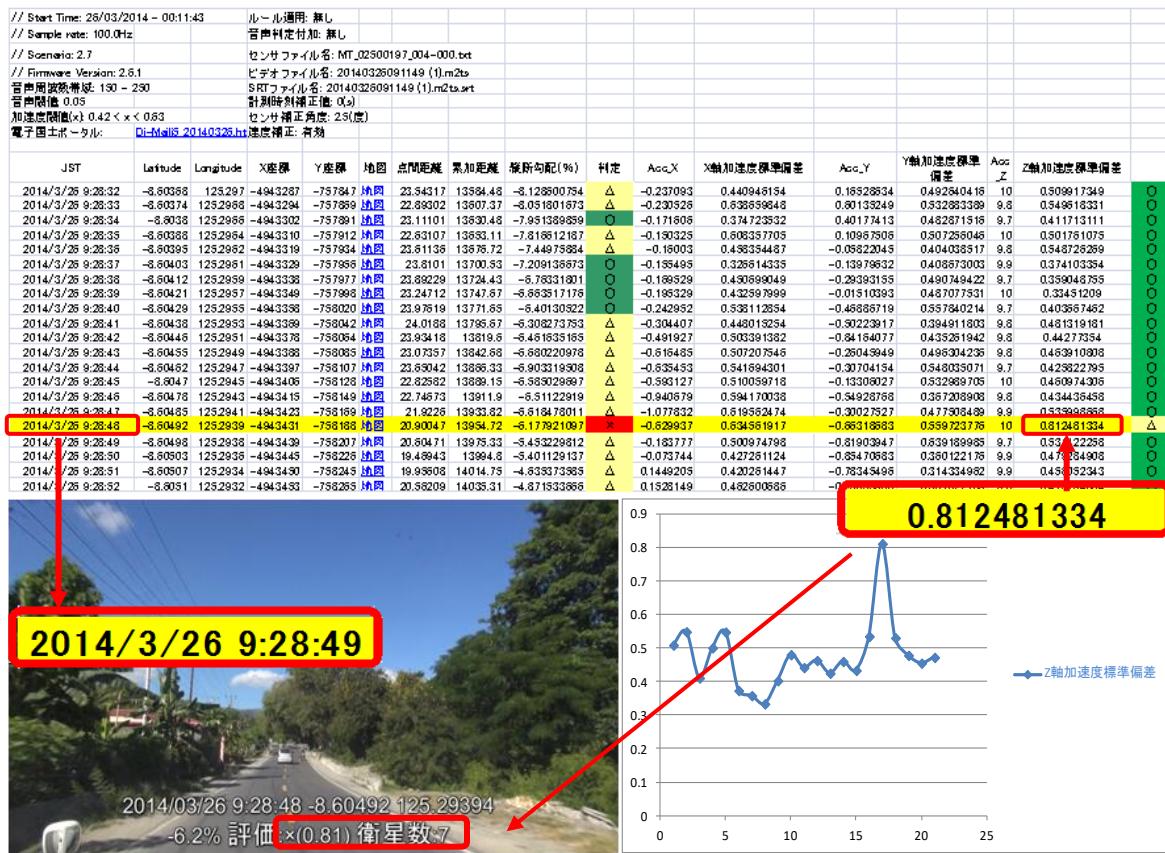
**Fig. 14.** Evaluation result for GOOD Timor-Leste road, obtained using Ippo-Campo

Figure 14 shows the results of evaluating a “GOOD” road in Timor-Leste. It can be seen that the use of both thresholds gives detailed information on the actual condition of this road. The threshold values play an important role in defining the standard deviation of the Z-axis evaluation (see Figures 1 and 2). This figure is just a small part of the road section. The selection of the interval uses a critical value obtained by calculating the statistical regression every second. For Japanese thresholds, this indicates that the condition is “overwhelmingly” MODERATE”.

Only a few items of data indicate the “GOOD” condition, and only one item of data corresponds to the “BAD” condition. However, this condition changes significantly after using the Timor-Leste threshold. Most condition changes are from “MODERATE” to “GOOD”. It can be seen that the maximum value of the Z-axis acceleration occurs at 0.812. The evaluation results can also be seen in the video data and Excel data, together with the time information and the status of the condition of the road.

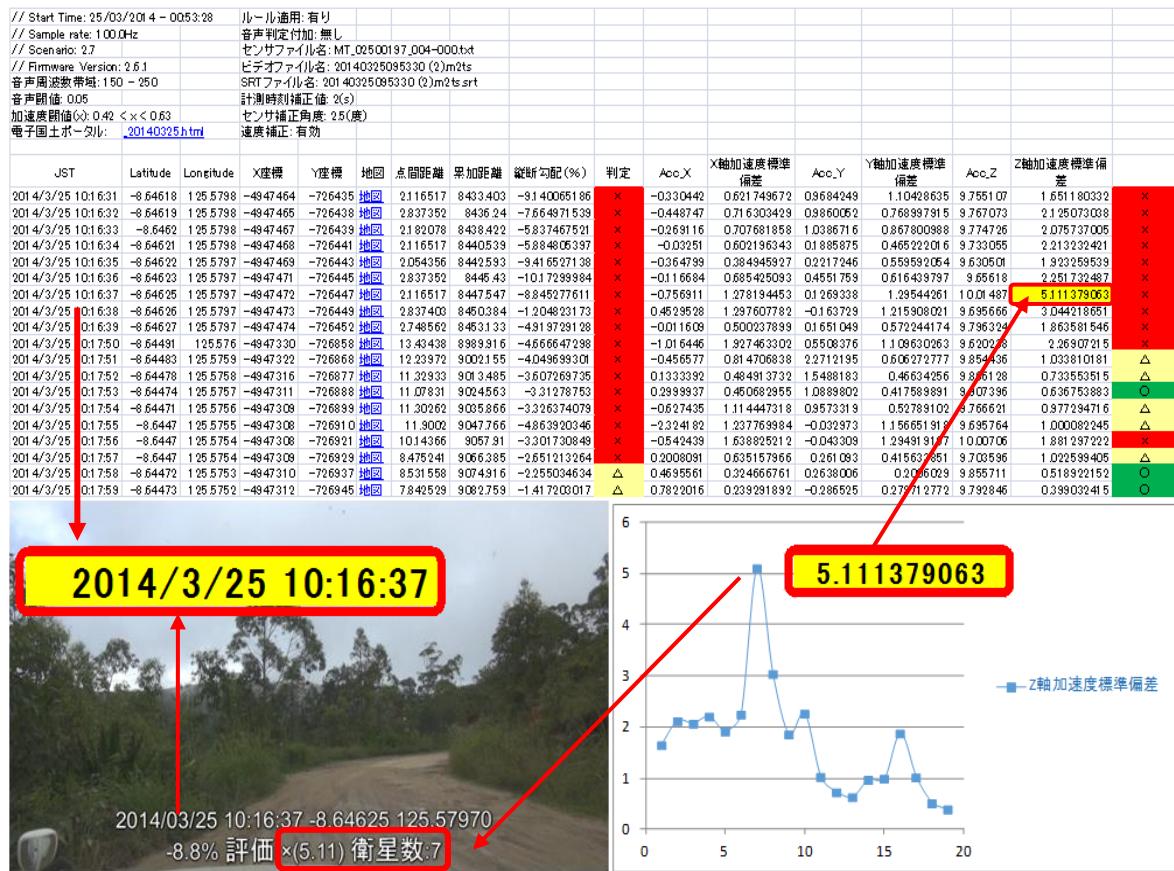
Fig. 15. Evaluation result for BAD Timor-Leste road, obtained using Ippo-Campo

Figure 15 shows an example of an evaluation result for a “BAD” condition road. It can be seen that the use of

thresholds plays an important role in making a judgment as to the actual condition of the road.

Using the Japanese threshold, the result shows that the road is in a very bad condition, relative to a rural road in Japan. Only two items of data indicate the “MODERATE” condition and none indicate that the road is in the “GOOD” condition. However, the condition changes slightly after using the Timor-Leste threshold, even if the condition is still dominated by the red color of the bad condition. It can be seen that the critical value reaches a maximum at 5.111, as shown in the Excel data and the video data.

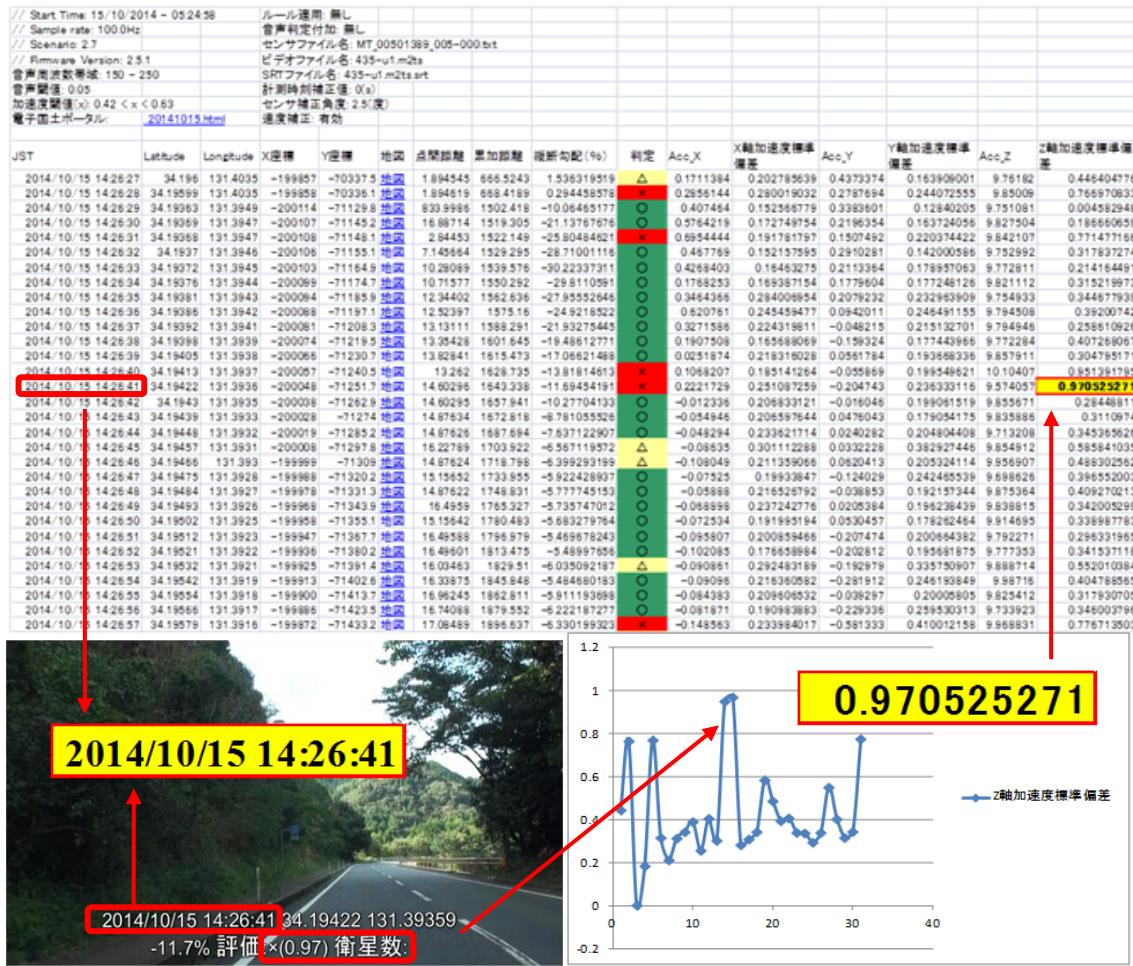
Fig. 16. Japanese road condition evaluation using Ippo-Campo system

In addition, the condition of the roads in Japan is very different from that existing in Timor-Leste; this can be seen in Figure 16. It can clearly be seen from the results of the evaluation done using Ippo-Campo that 69.4% of the roads are in “GOOD” condition, 22.3% are in “MODERATE” condition, and only 8.3% are in “BAD” condition. It is notable that the maximum value of the standard deviation of the Z-axis acceleration is 0.971.
